# **INDOOR AIR QUALITY ASSESSMENT**

**Summer Street School  
262 Summer Street  
Lynnfield, MA 01940**

Prepared by:  
Massachusetts Department of Public Health  
Center for Environmental Health  
Emergency Response/Indoor Air Quality Program  
August 2006

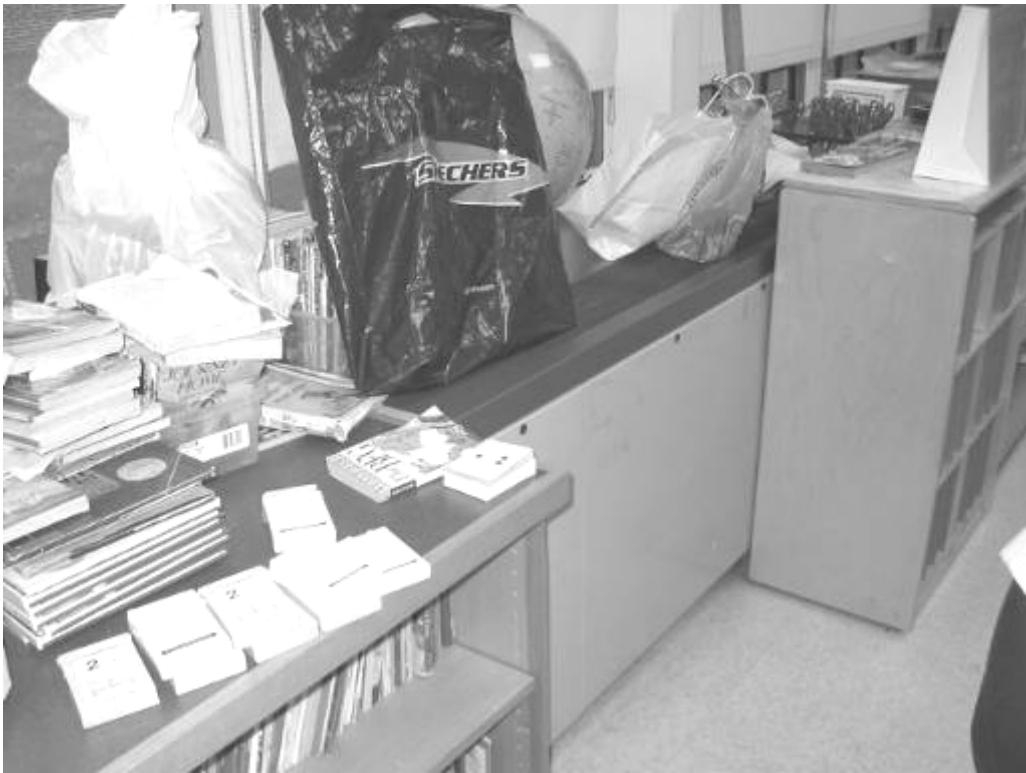
**Picture 1**

**Univent Obstructed by Items on Top and in front of Return Vent (along front/bottom)**

4. Remove all blockages from univents to ensure adequate airflow.
5. Close classroom doors to improve air exchange.
6. Consider adopting a balancing schedule of every 5 years for mechanical ventilation systems, as recommended by ventilation industrial standards (SMACNA, 1994).

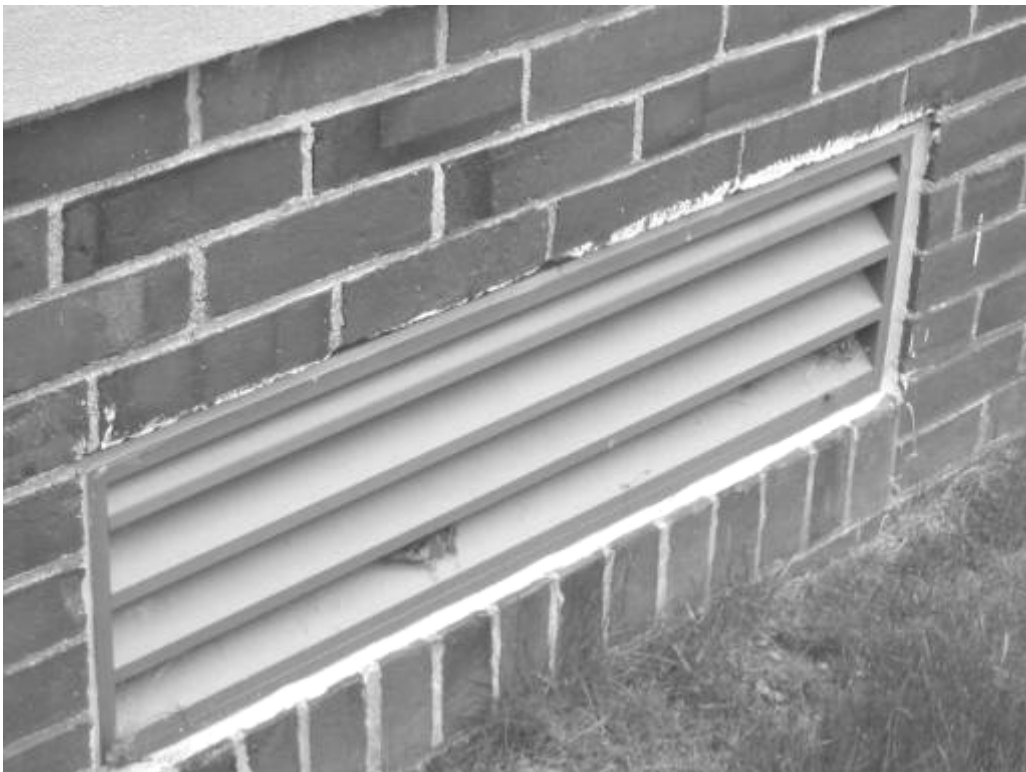
**Picture 2**

**Univent Fresh Air Intake, Note Materials in between Louvers**

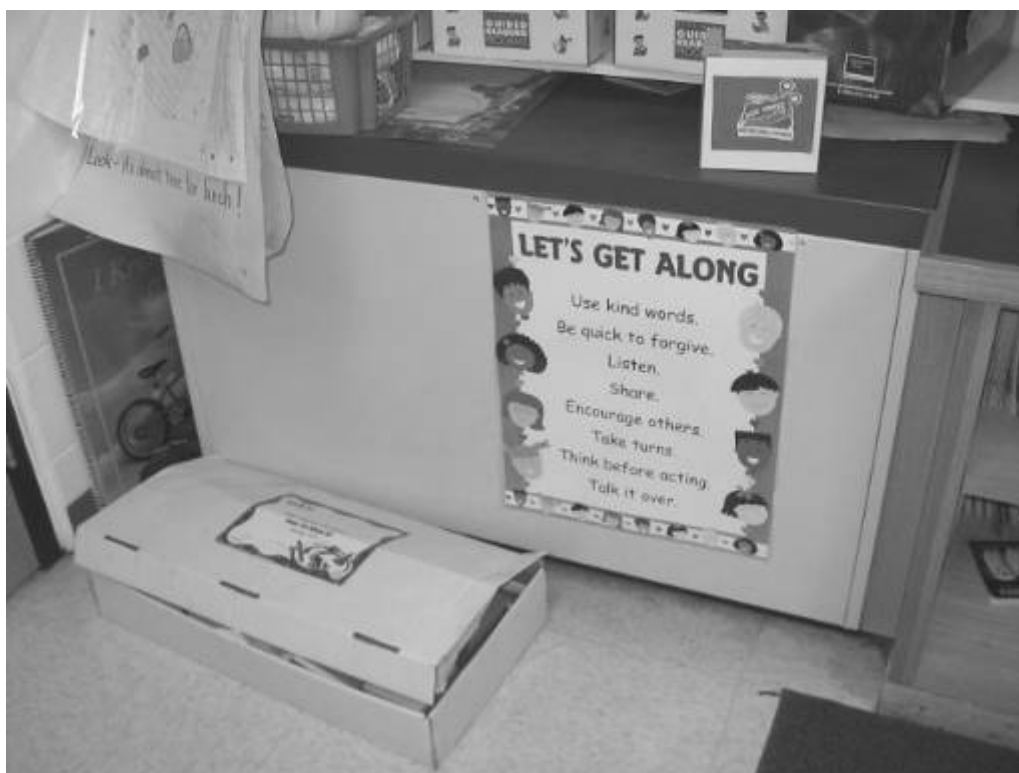
**Picture 3**

Mechanical exhaust ventilation in classrooms in the original building is provided by unit exhaust ventilators (Picture 3). A unit exhaust ventilator appears similar to a univent, but

removes air from the classroom and exhausts it out of the building. Unit exhaust ventilators appeared to be off or operating weakly in several areas during the assessment. Without sufficient supply and exhaust ventilation, normally occurring environmental pollutants can build-up and lead to indoor air quality/comfort complaints. The mechanical exhaust ventilation system in the addition consists of wall-mounted exhaust vents (Picture 4) ducted to rooftop motors. As with the univents, wall-mounted exhaust vents were obstructed by various items limiting airflow.

**Unit Exhaust Ventilator**

2. Inspect exhaust motors and belts for proper function. Repair and replace as necessary.
3. Work with town/school officials to develop a preventative maintenance program for all HVAC equipment system-wide.

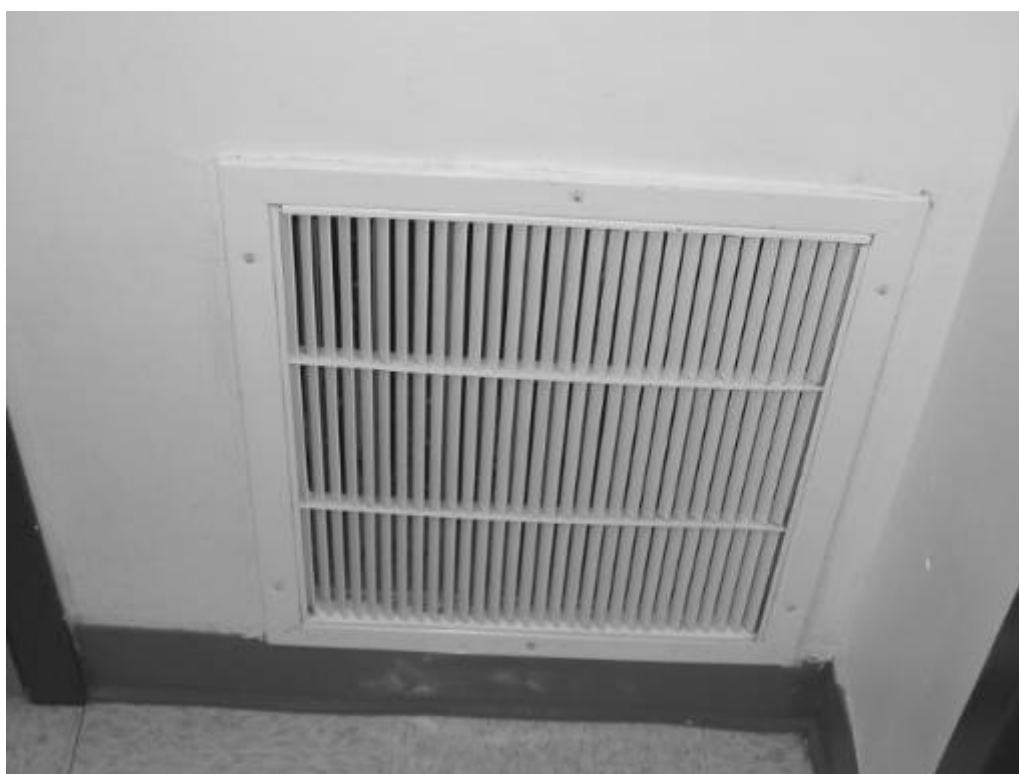
**Picture 4**

**Wall-Mounted Exhaust Vent**

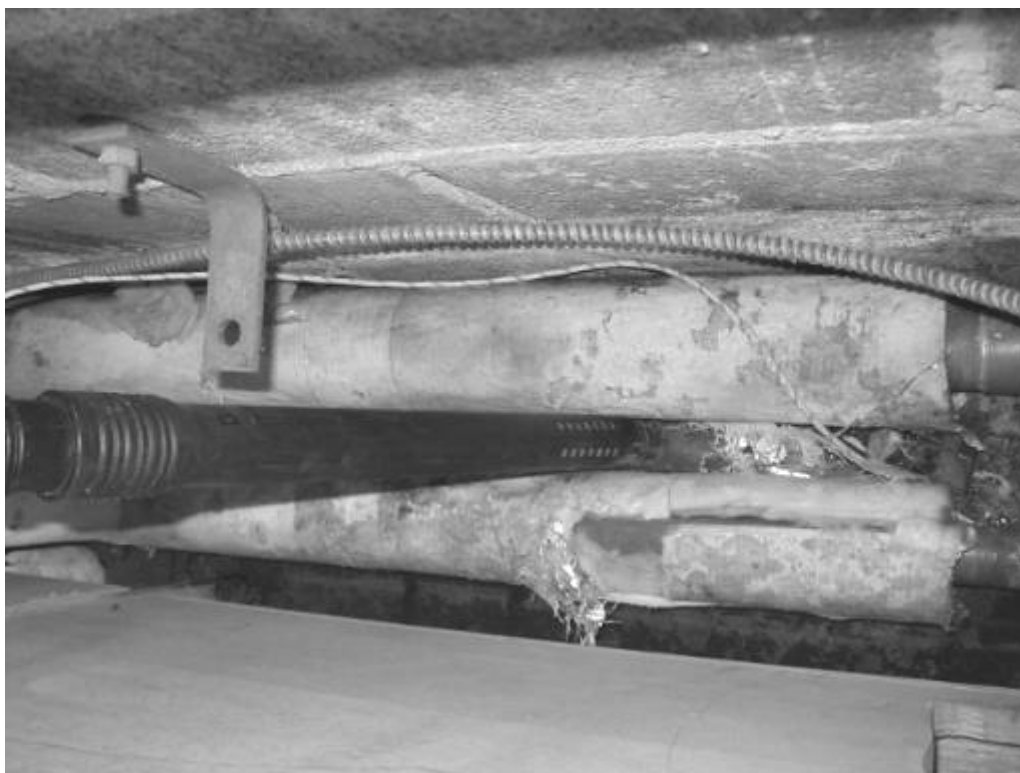
**Picture 5**

An active plumbing leak was observed in room 113, which caused damage to insulation and wood coving (Pictures 5 and 6). The US Environmental Protection Agency (US EPA) and

Water content of insulation and wood was measured with a Delmhorst, BD-2000 Model, Moisture Detector with a Delmhorst Standard Probe. The Delmhorst probe is equipped with three lights as visual aids to determine moisture level. Readings, which activate the green light, indicate a sufficiently dry level, those that activate the yellow light indicate borderline conditions and those that activate the red light indicate elevated moisture content. Elevated moisture readings were measured in both insulation and wood in classroom 113 (Table 1).

**Water Damaged Insulation in Room 113**

10. Ensure plumbing leak in room 113 is repaired. Remediate any water damaged/mold contaminated materials in a manner consistent with recommendations in “Mold Remediation in Schools and Commercial Buildings” published by the US Environmental Protection Agency (US EPA, 2001). Copies of this document can be downloaded from the US EPA website at: [http://www.epa.gov/iaq/molds/mold\\_remediation.html](http://www.epa.gov/iaq/molds/mold_remediation.html).

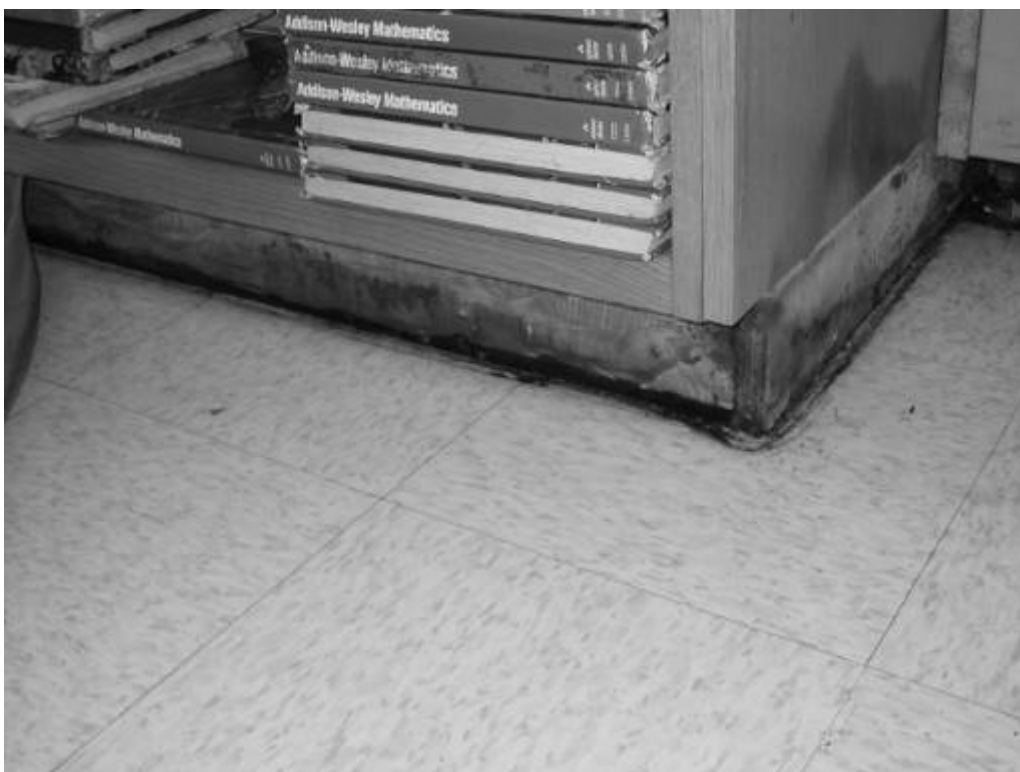
**Picture 6**

**Water Damaged Bookcase in Room 113**

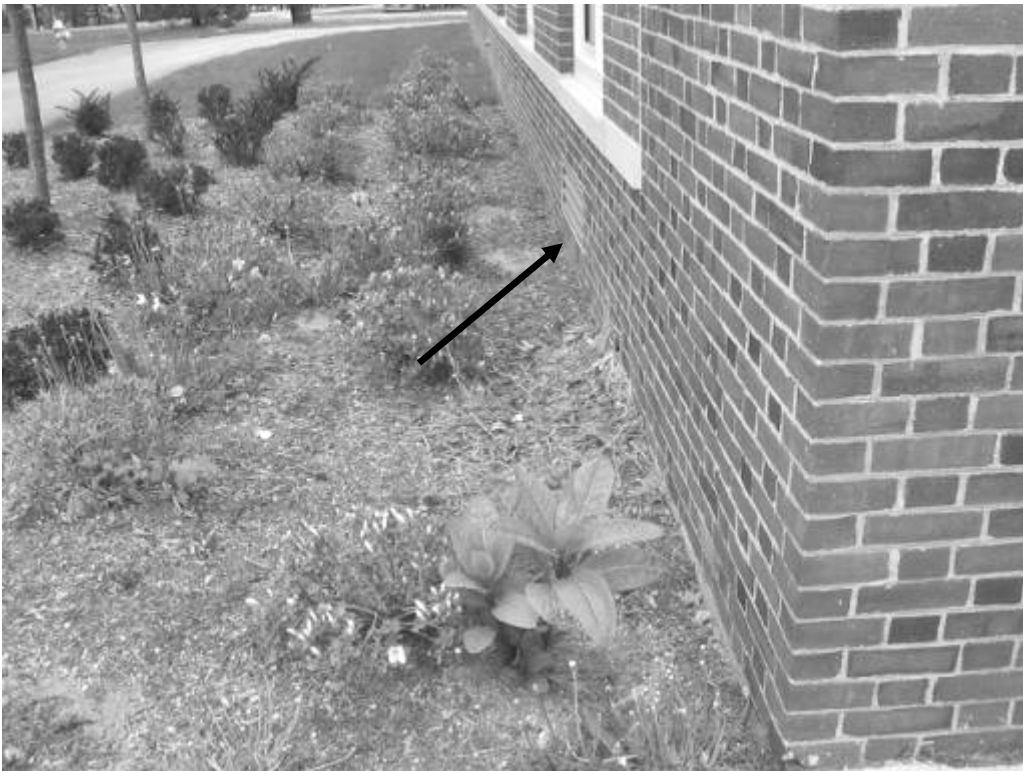
**Picture 7**

Musty odors were reported by occupants in several classrooms along the perimeter of the building. The origin of the odor appeared to be from fresh mulch which had recently been spread prior to the CEH assessment. The area where the mulch is located is in close proximity to

univent fresh air intakes (Picture 7), which can draw in odors and distribute them throughout the classroom.

**Mulched Area near Univent Air Intake (Indicated by Arrow)**

15. Consider discontinuing the use of mulch during or immediately prior to school occupancy to prevent the entrainment of musty odors.
16. Relocate or consider reducing the amount of materials stored in classrooms to allow for more thorough cleaning. Clean items regularly with a wet cloth or sponge to prevent excessive dust build-up.

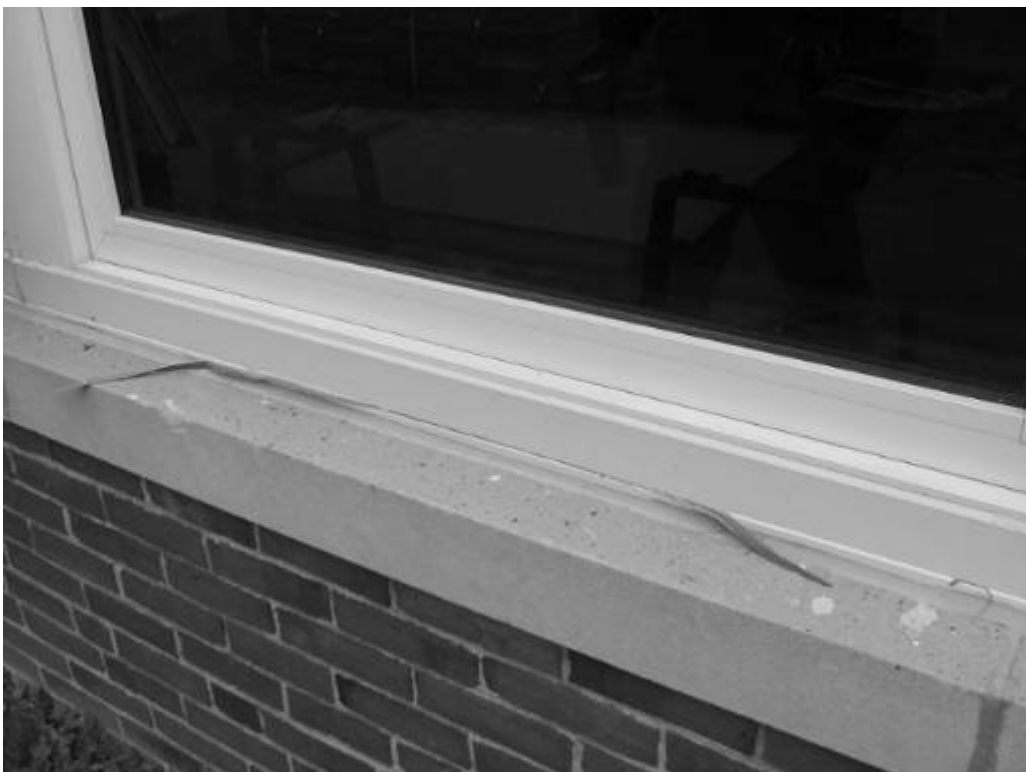
**Picture 8**

Exterior caulking around windows and frames was failing/damaged in a number of areas, indicating that the water seal is no longer intact (Pictures 8 and 9). Replacement of caulking and repairs of window leaks are necessary to prevent water penetration and subsequent damage to building materials, which can lead to mold growth. Missing/damaged mortar and spaces in brick was also observed on the exterior of the building (Picture 10). Repeated water penetration can result in the chronic wetting of building materials and potentially lead to microbial growth. In addition, these large cracks/holes in the exterior wall may provide a means of egress for pests/rodents into the building.

**Failing Caulking around Window Frame**

13. Contact a masonry firm or general contractor to repair holes/breaches in exterior walls to prevent water penetration, drafts and pest entry. Consider repointing building.

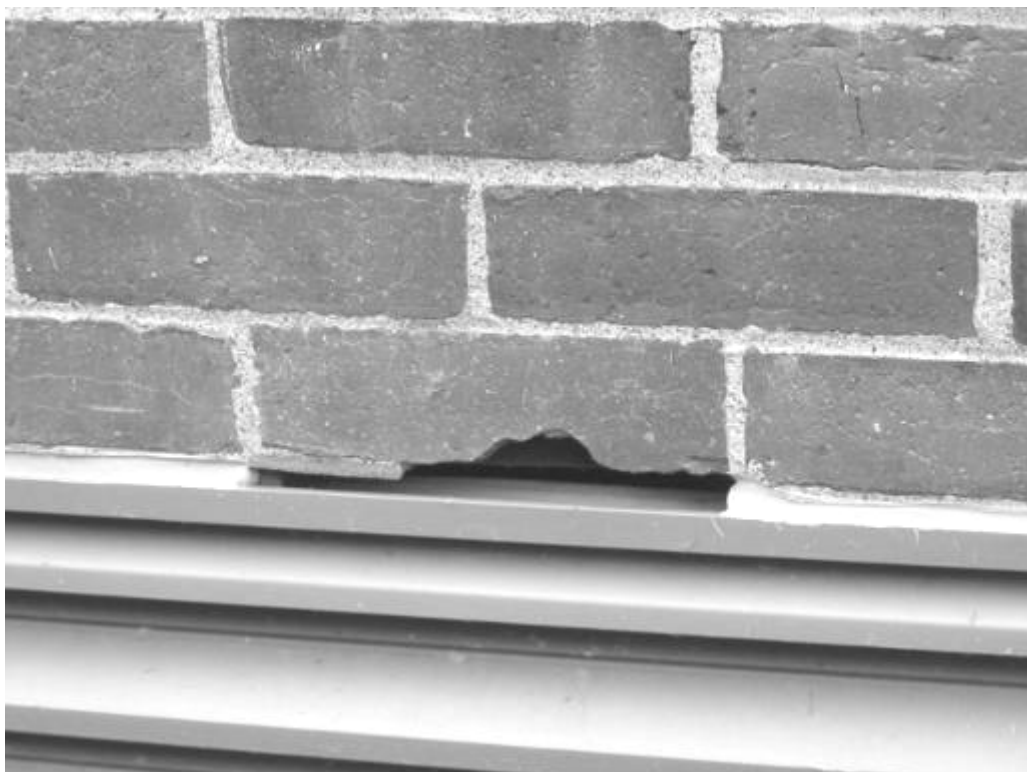
**Picture 10**

**Damaged Brick/Missing Sealant around Univent Air Intake**

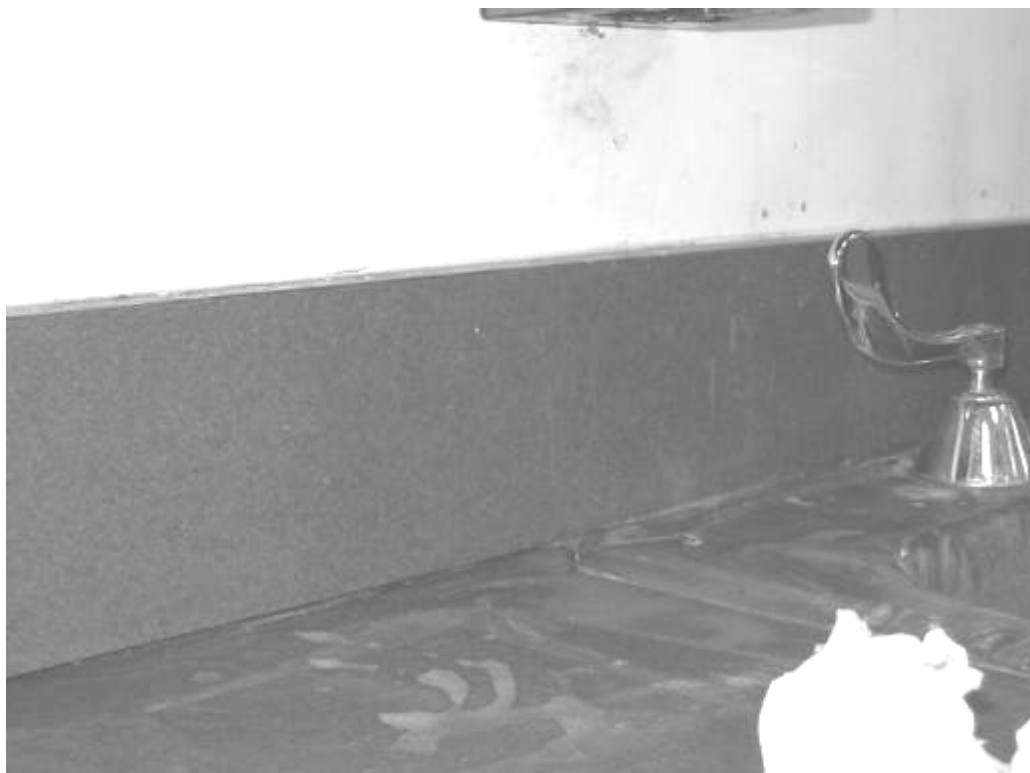
**Picture 11**

Spaces between the sink countertop and backsplash were noted in several classrooms (Picture 11/Table 1). Improper drainage or sink overflow can lead to water penetration to countertop wood, the cabinet interior and areas behind cabinets. Like other porous materials, if these materials become wet repeatedly they can provide a medium for mold growth.

**Space Between Backsplash and Sink Countertop**

11. Seal areas around sinks to prevent water-damage to the interior of cabinets and adjacent wallboard.
12. Once repairs are made, replace water damaged ceiling tiles. Examine the area above and around water-damaged areas for mold growth. Disinfect areas with an appropriate antimicrobial as needed.

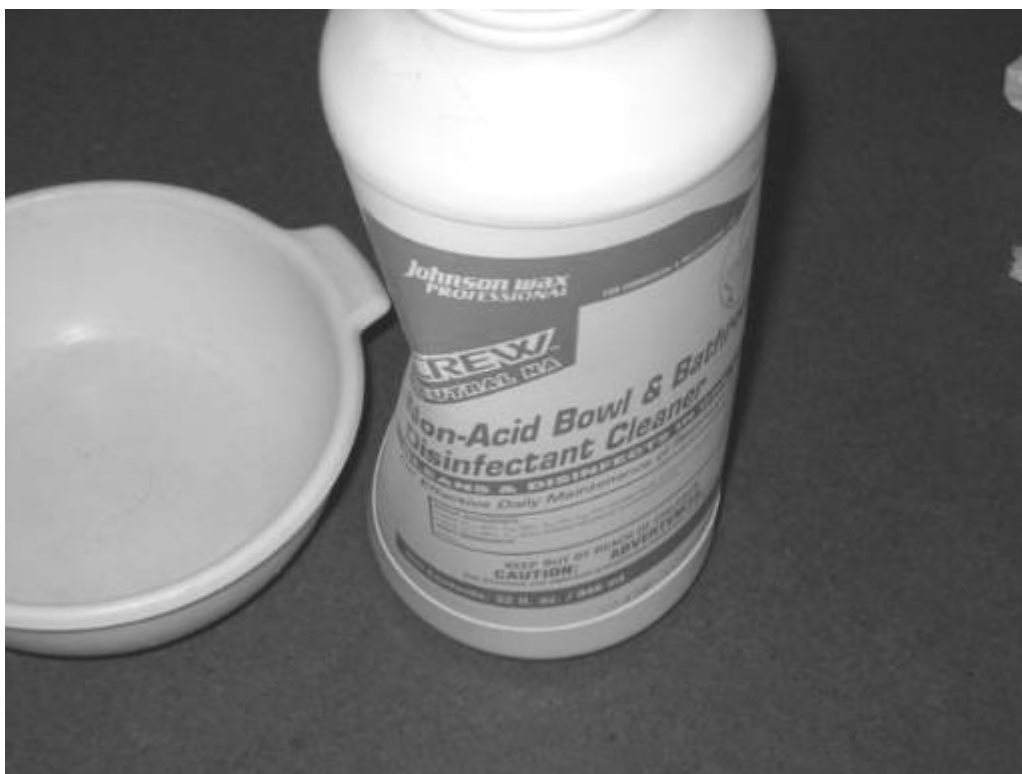
**Picture 12**

Spray cleaning products and unlabelled spray bottles were observed on countertops in a number of classrooms (Pictures 12 and 13). Cleaning products contain VOCs and other chemicals, which can be irritating to the eyes, nose and throat and should be stored properly and

**Cleaning Agent**

17. Store cleaning products properly and out of reach of students. Ensure spray bottles are properly labeled in the event of an emergency. Maintain MSDS for all cleaning products in a central location.

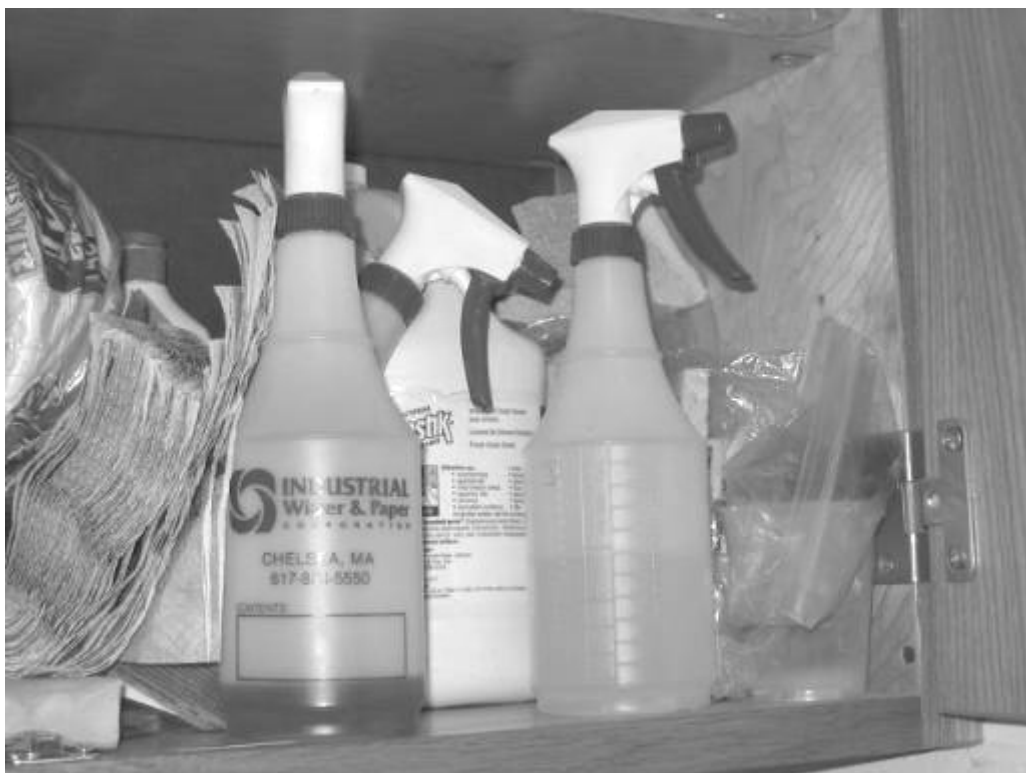
**Picture 13**

**Cleaning Agents**

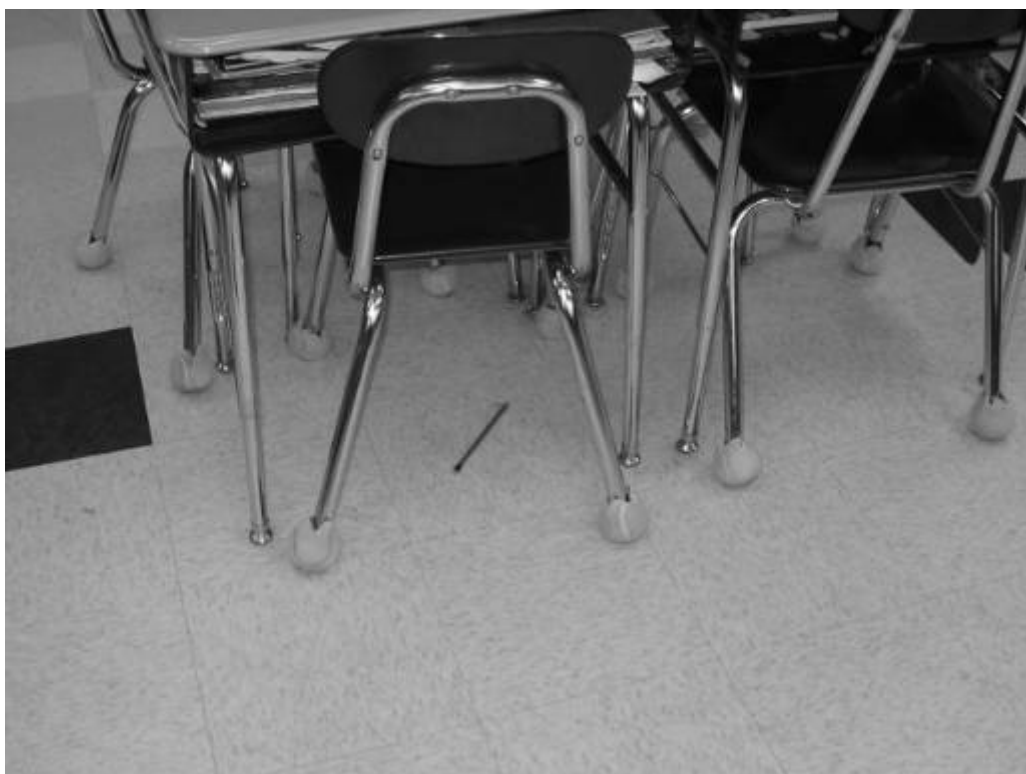
**Picture 14**

In an effort to reduce noise from sliding chairs, tennis balls had been sliced open and placed on chair legs (Picture 14) in a few classrooms. Tennis balls are made of a number of materials that are a source of respiratory irritants. Constant wearing of tennis balls can produce fibers and cause TVOCs to off-gas. Tennis balls are made with a natural rubber latex bladder, which becomes abraded when used as a chair leg pad. Use of tennis balls in this manner may introduce latex dust into the school environment. Some individuals are highly allergic to latex (e.g., spina bifida patients) (SBAA, 2001). It is recommended that the use of materials containing latex be limited in buildings to reduce the likelihood of symptoms in sensitive individuals (NIOSH, 1997). A question and answer sheet concerning latex allergy is attached as

**Tennis Balls on Chair Legs**

18. Clean fan blades and exhaust and supply vents periodically to prevent excessive dust build-up.
19. Consider replacing tennis balls on chair legs with alternative glides.

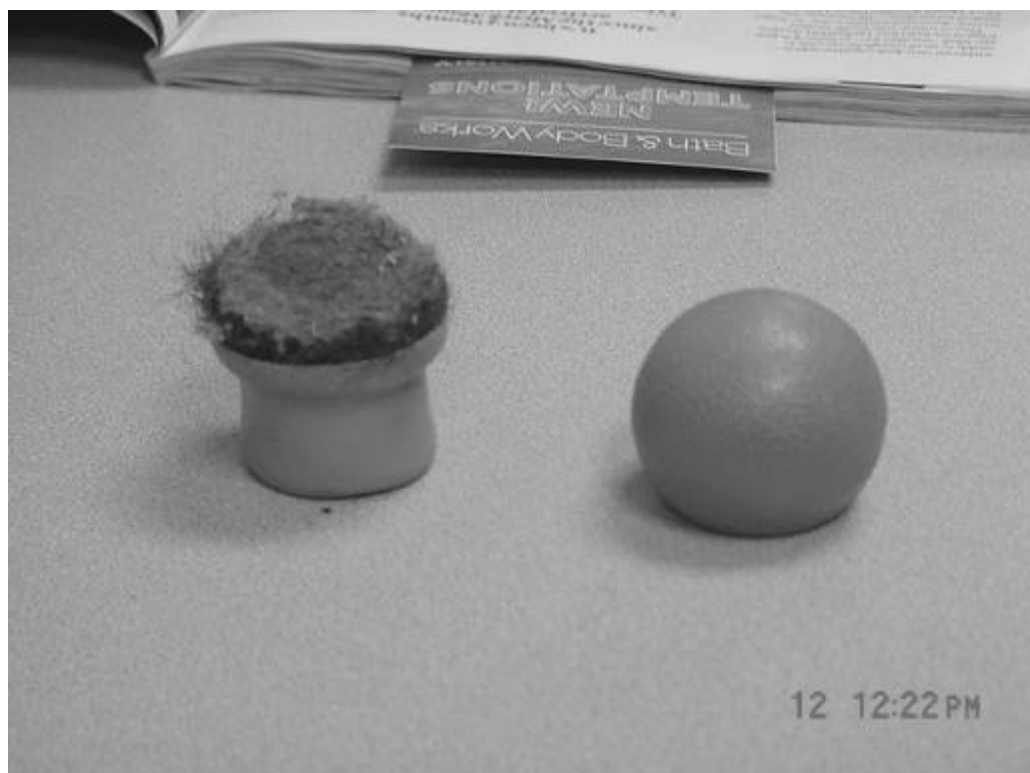
**Picture 15**

[Appendix B](#) (NIOSH, 1998). Consideration should be made towards replacing tennis balls with alternative glides (Picture 15).

**Examples of Alternative Glides**
